The Parish Church of St. Andrew
at

DEOPHAM : NORFOLK

THE NINTH QUINQUENNIAL INSPECTION REPORT

Date of Inspections : Wednesday 26th January, Friday 4th and
Wednesday 9th February 2022
RAB:LEB

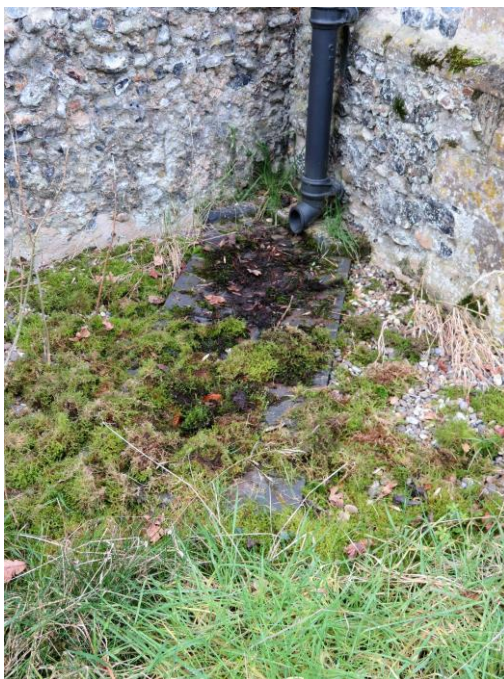
Fig 1.

The cast iron rainwater goods on the chancel are satisfactory but ought to be regularly maintained, and the surface water drains in good order, although vegetation on the new brick channels and gullies needs to be removed, *see fig 1*, and the rainwater goods regularly cleaned out. Details of the new surface water drains serving the chancel are detailed on the attached drawing dated 14th August 2017.

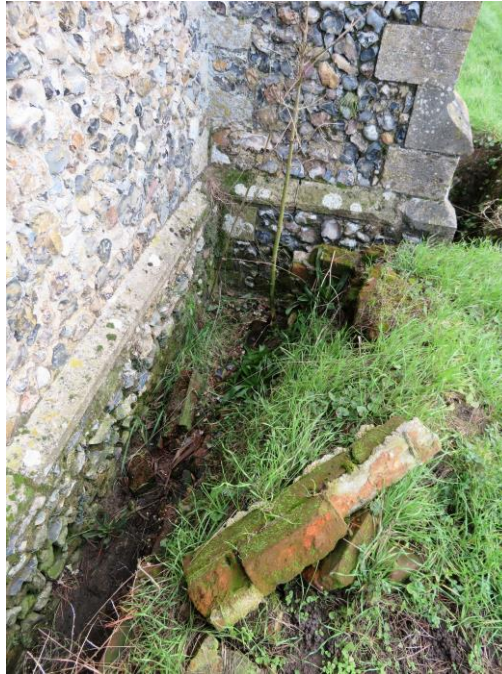
Fig 2.

There are no rainwater goods on the nave, or north or south aisles or south porch, where water drips into the channels below. Along the south side of the church, the brick-lined channels against the walls of the porch and south aisle are in a poor condition, as there is vegetation and debris in them and deterioration to the retaining walls that, in some areas, are cracked and have partially collapsed. It would therefore be advisable to clean out the channels, carry out any repairs to cracks and open joints and repair the brick retaining walls, having removed invasive vegetation. This should include removing the small tree that grows from the collapsed retaining wall at the east end of the south aisle, *see fig 2*. There are also numerous open joints to the plinth flint and stonework, within the channel, that ought to be repointed.

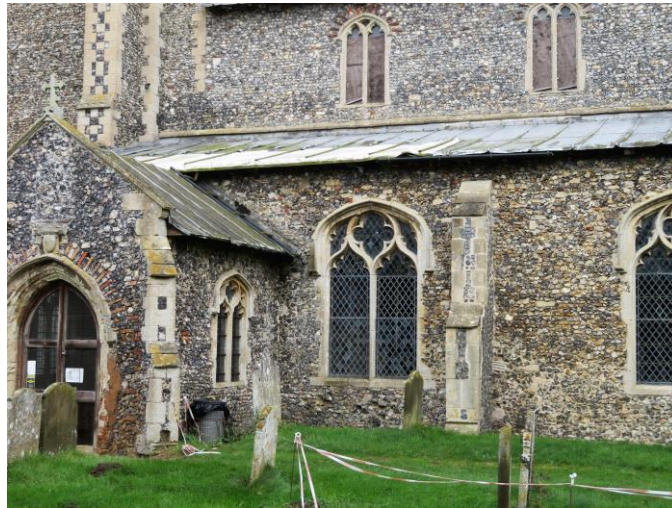
Fig 3.

The leadwork on the south aisle roof is in a poor condition as it has failed throughout and been covered with a reinforced bitumen, and sheets towards the west end have subsequently been stolen. *See fig 3.*

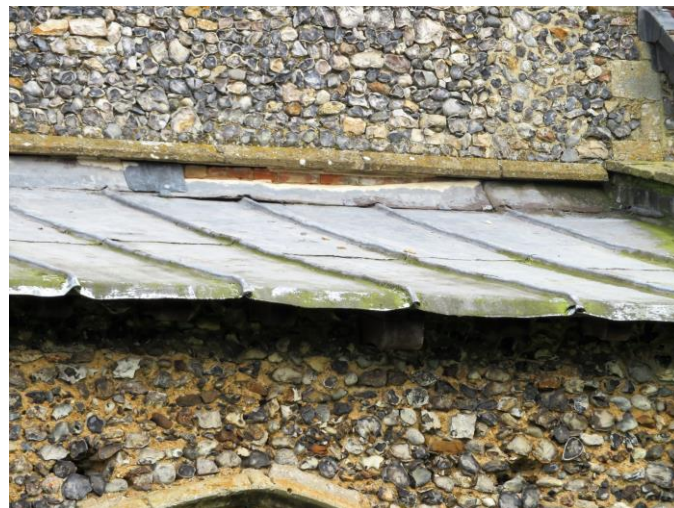
Fig 4.

The flashings, that are also in a poor condition, have been patch-repaired on numerous occasions and, towards the east end of the clerestory wall, have fallen away, *see fig 4*. The roof also leaks throughout the south aisle, indicating that it needs to be re-leaded as a matter of urgency. Along the eaves, the exposed rafter feet and the boards above are in reasonable condition but beginning to suffer from water ingress.

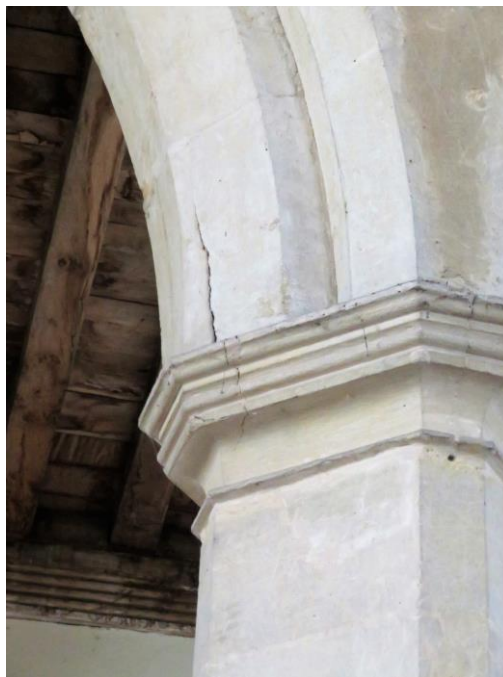
Fig 5.

Within the nave, the crack that has been repointed at the east end of the south arcade appears to be sound, but there are hairline cracks to the soffits of the clerestory windows that should be noted. The hairline crack that has been filled above the tower arch also remains sound. Three hairline cracks are also visible above the westernmost north arcade arch where, on the east side of the arch, the crack continues within the lining stones and has caused the nosing of the lower voussoir stone to crack. *See fig 5.* There are further hairline cracks above and below the second north clerestory window from the west and above and below the easternmost window that should be noted, but the crack that has been repointed above the east side of the easternmost north arcade arch remains sound.

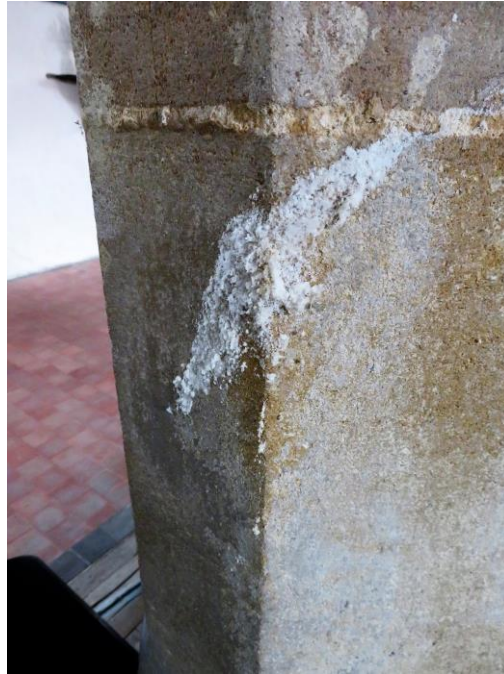
Fig 6.

The limewashed east wall of the nave and chancel arch is in good condition with the exception of minor areas of deterioration to the render at low level either side of the arch, where green algae have encroached onto the walls. Elsewhere the rendered finish to the north and south clerestory walls and the west wall, above the tower arch, is in reasonable condition apart from some areas of detached render between the easternmost and second south clerestory windows from the east that ought to be repaired and the walls swept clean to improve their appearance. Salts that are appearing on the base of the north arcade column should also be removed because, if they are left in place, they will cause delamination to the stonework. *See fig 6.*

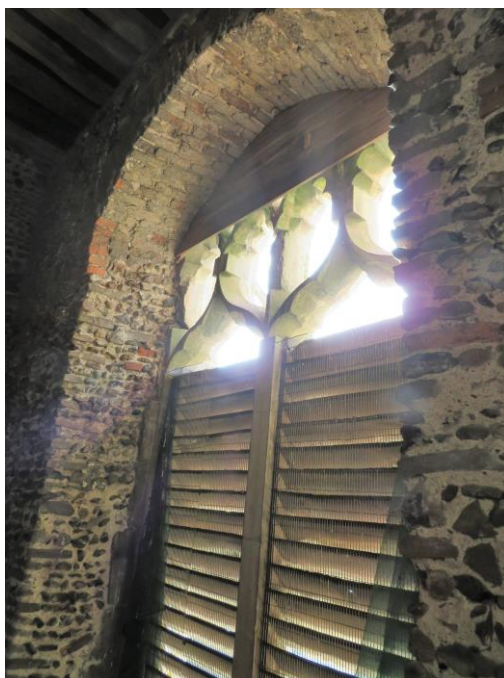
Fig 7.

The tower roof and upper staircase at belfry level were not inspected as part of this report due to the extent of pigeon guano and nesting pigeons on the upper steps and throughout the belfry, as pigeons are gaining access through the tracery lights to the south belfry sound opening where the boards have fallen away. *See fig 7.* Consequently, there is a large amount of guano on the bell frame and on the access platform and ladders, staircases and much of the belfry floor, all of which needs to be removed.

The tower roof and upper staircase should then be inspected.

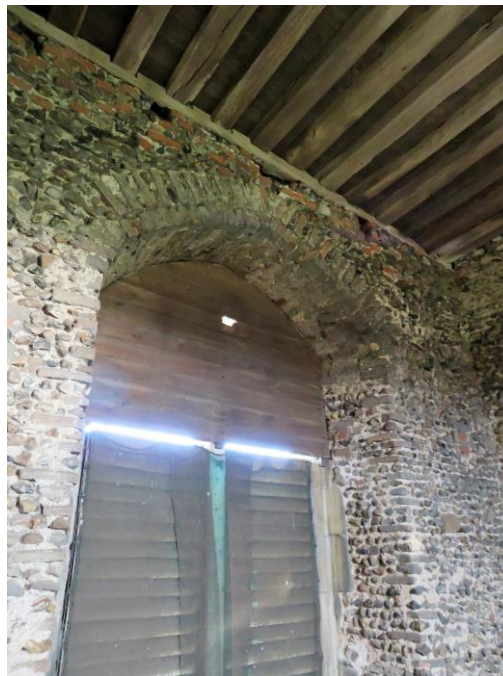
Fig 8.

The boards and mesh and debris netting to the four belfry sound openings are in reasonable condition with the exception of the missing boards to the tracery lights of the south sound opening, a hole that has been created in the boards at the top of the north sound opening, possibly by a woodpecker, and detached areas of debris netting that need to be reinstated. *See fig 8.*

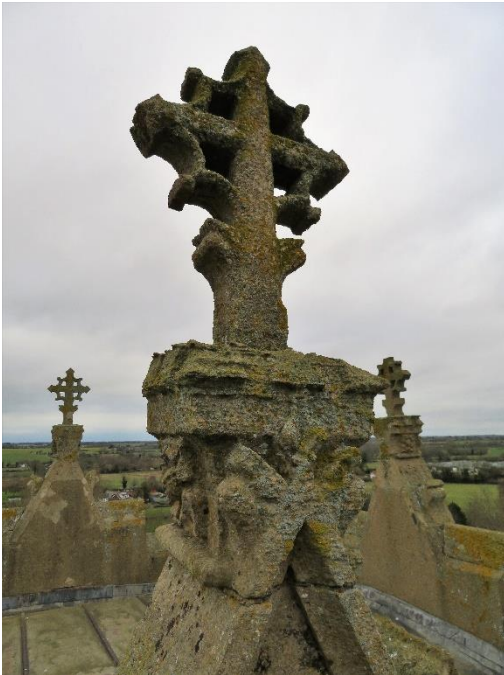
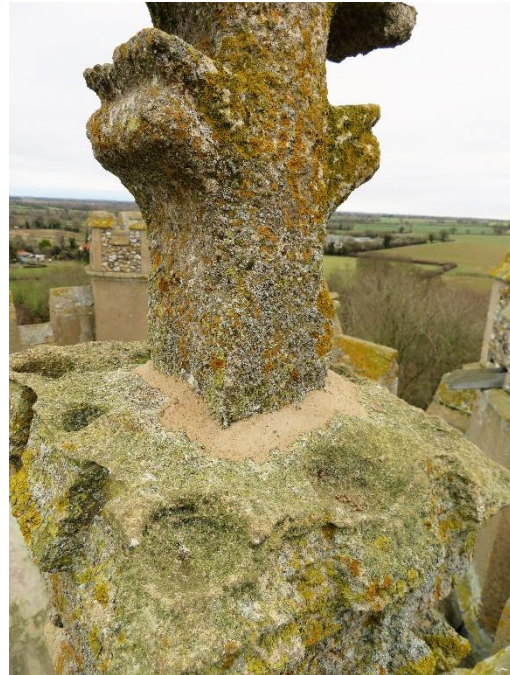
- a) The cross on the apex of the parapet pediment was found to be loose and wedged and pointed within its stooling, although in the longer term this ought to be rebedded and pinned. This could be done from scaffolding from the tower roof and in conjunction with clearing debris from the roofs of the four tower parapet turrets, cleaning the belfry and staircases and reinstating the collapsed horizontal boarding from the tracery lights of the south sound opening.

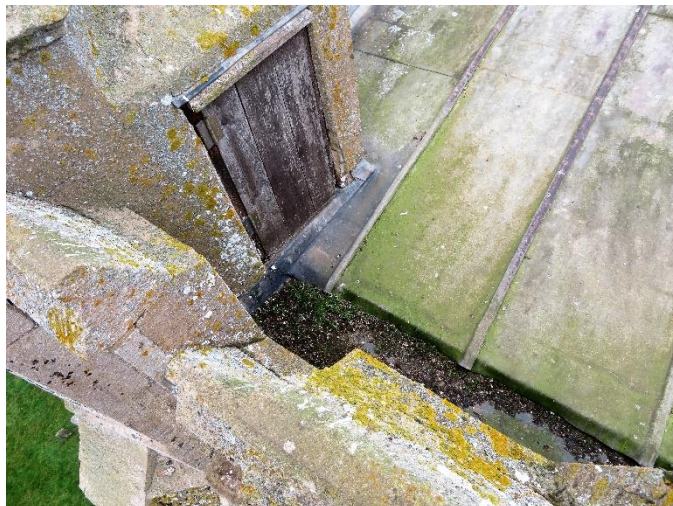
- b) There is debris in the south tower parapet gutter that needs to be removed.

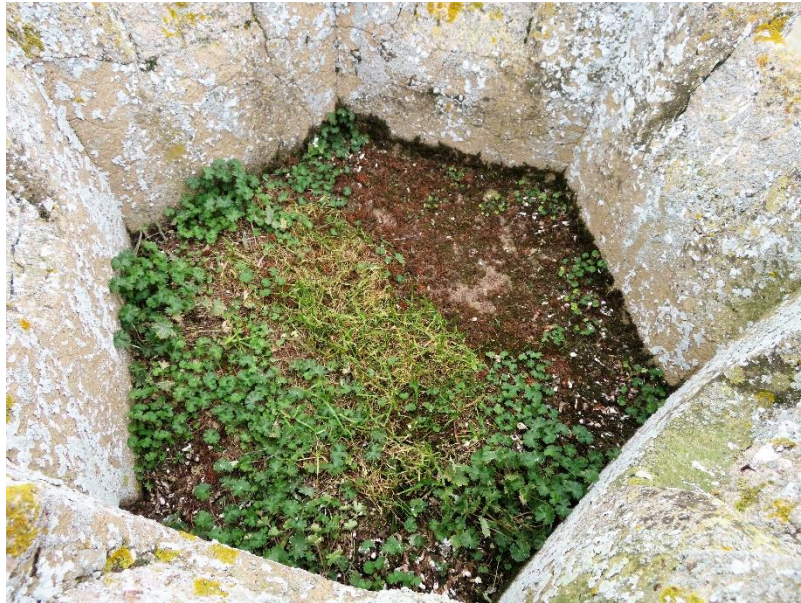
- c) The southwest turret is covered in vegetation and needs to be cleared and the outlet to the southwest rodded.

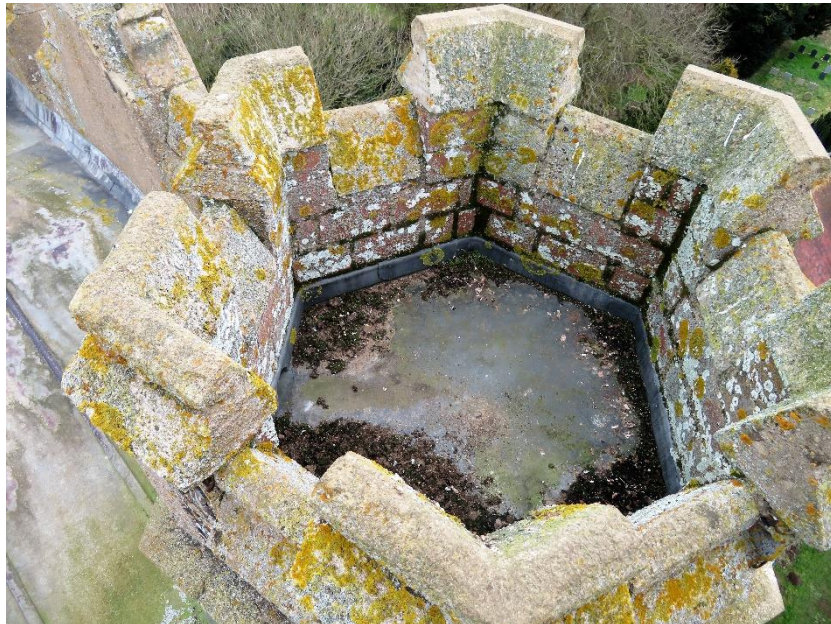
- d) To the southeast the turret roof is covered in leadwork that appears to be in good condition but ought to be swept clean.

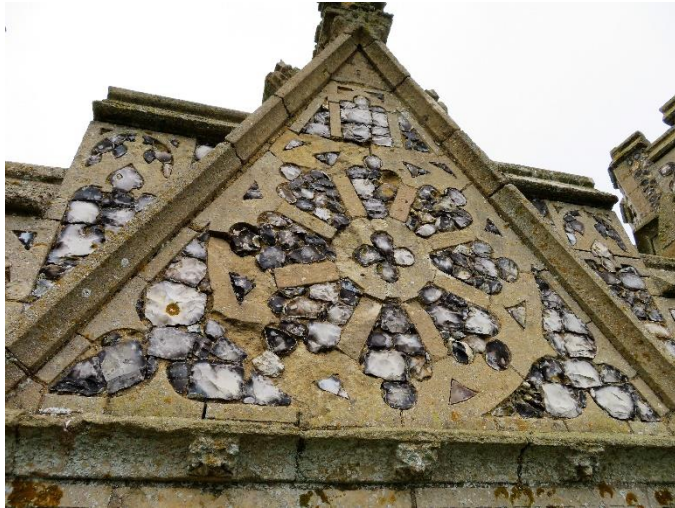
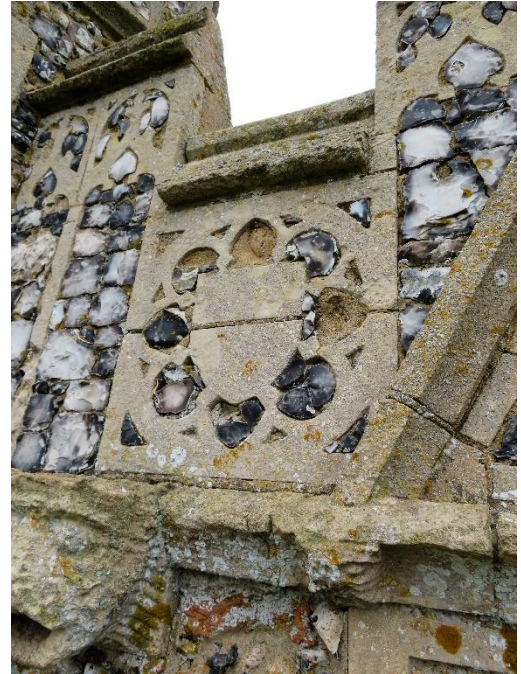
- e) There are several eroded joints to the south parapet stonework, some missing knapped flints and one loose flint to the east of the pediment that was rebedded. The parapet stonework could be repointed from a cherrypicker that should include rebedding any loose flints or reinstating any missing flints, from the decorative flushwork.

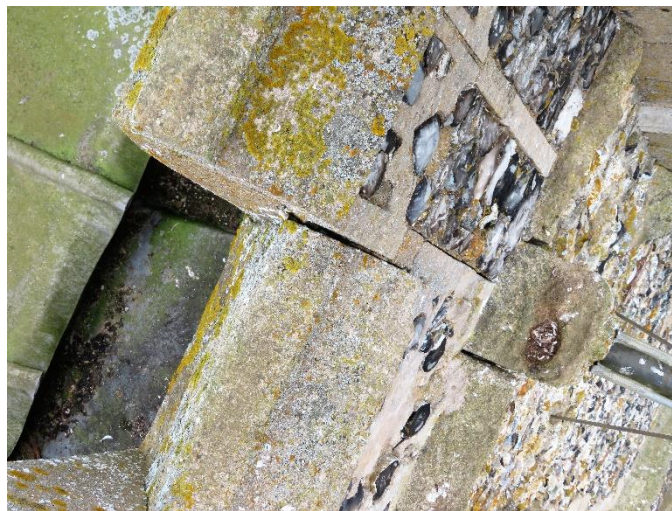
- f) There are a number of open joints to the parapet stringcourse that need to be repointed.

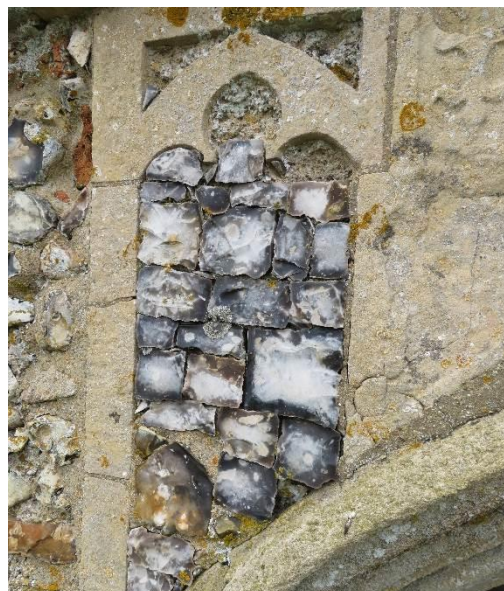
- g) There are two loose flints within the knapped flint panel to the west of the head of the south belfry sound opening, that need to be rebedded.

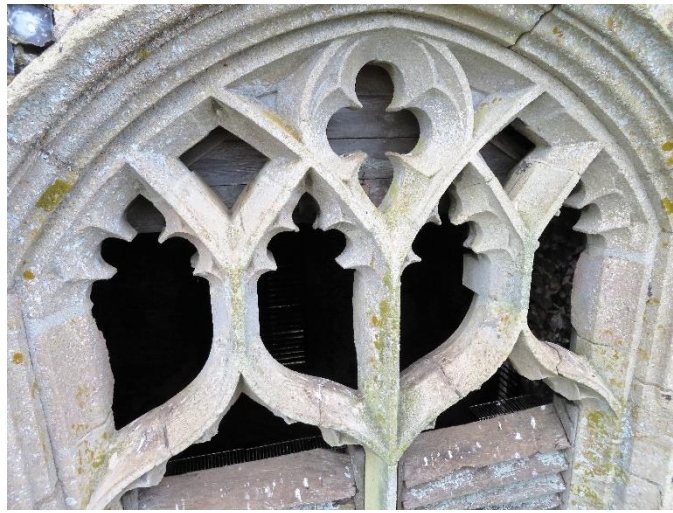
- h) The missing horizontal boards from the tracery lights to the south sound opening have been temporarily replaced with debris netting and need to be refixed to the opening.

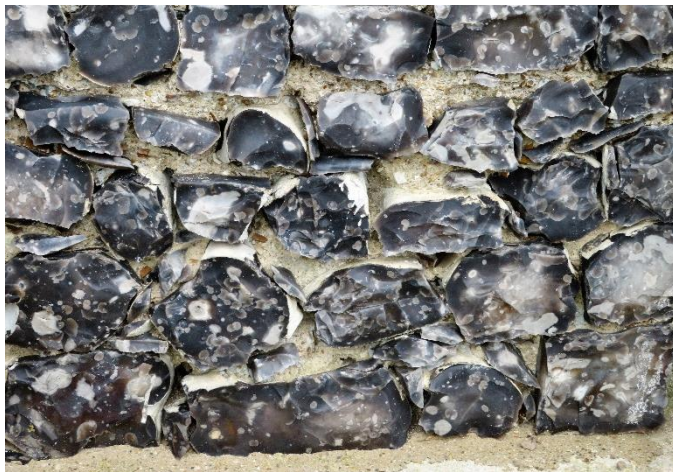
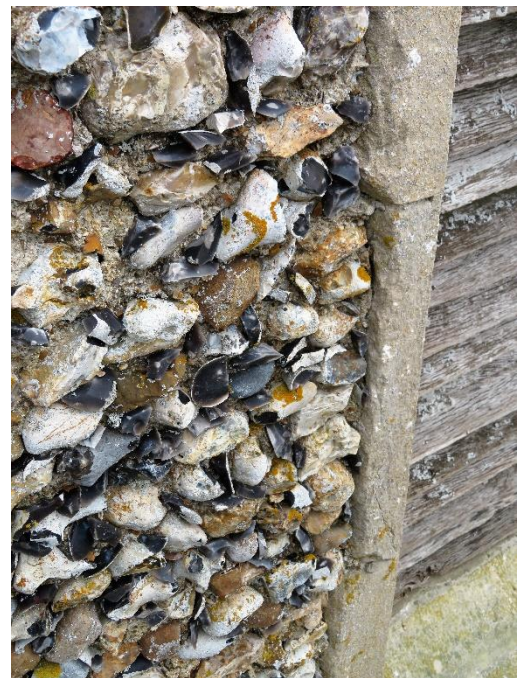
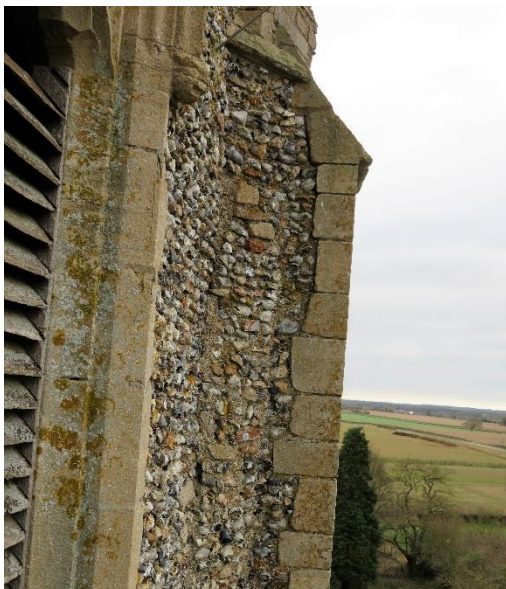
- i) The mortar joints to the flint work are deeply eroded throughout the south elevation that needs to be repointed with particular attention to wide open joints behind the jambs and buttress quoins that could be pointed in isolation to prevent further deterioration to the stonework that would lead to instability. Open joints to the sound opening cill also require pointing

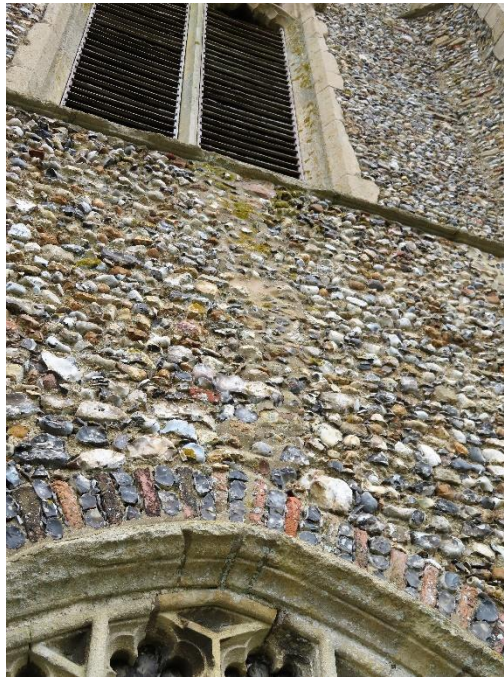
- j) A mortar tell tale has been applied to crack below the south belfry sound opening.

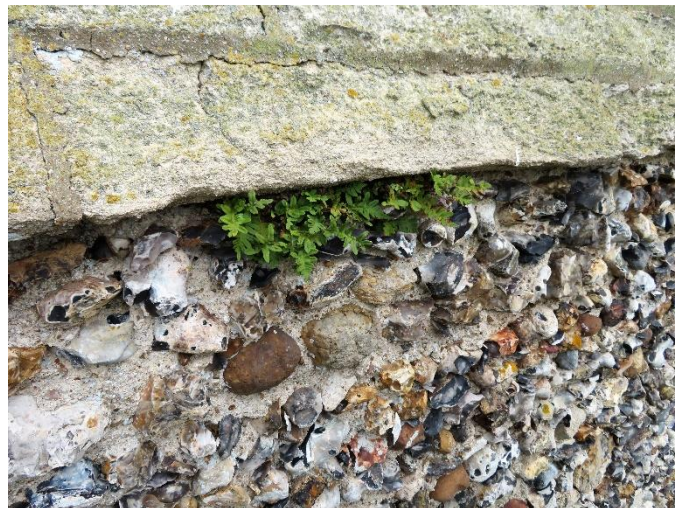
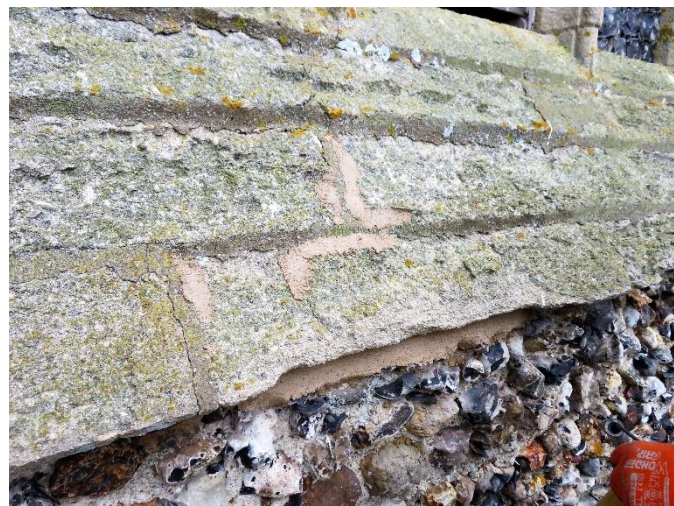
- k) The ferns growing under the south silence chamber stringcourse, in two locations, have been removed and a deep open root pockets and an open joint through the stringcourse above, repointed.

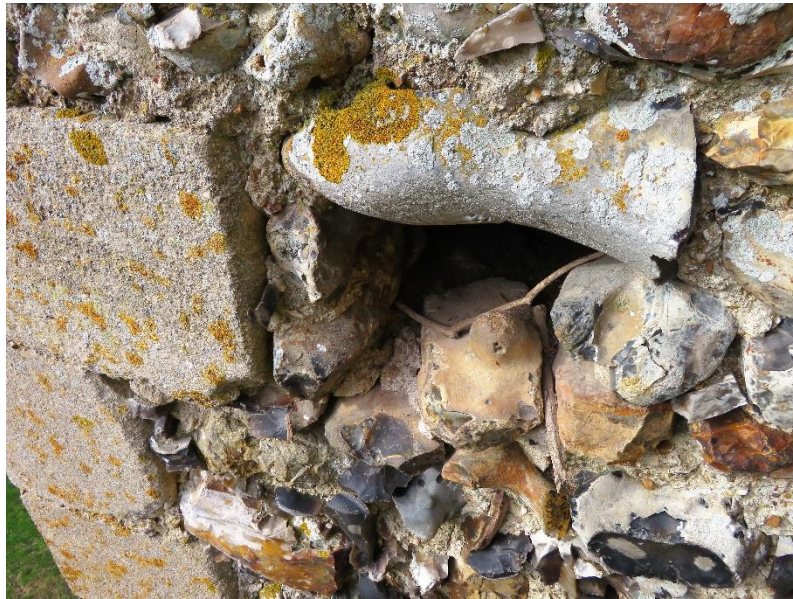
- 1) On the east face of the westernmost south tower buttress, a loose flint to the putlog hole was rebedded

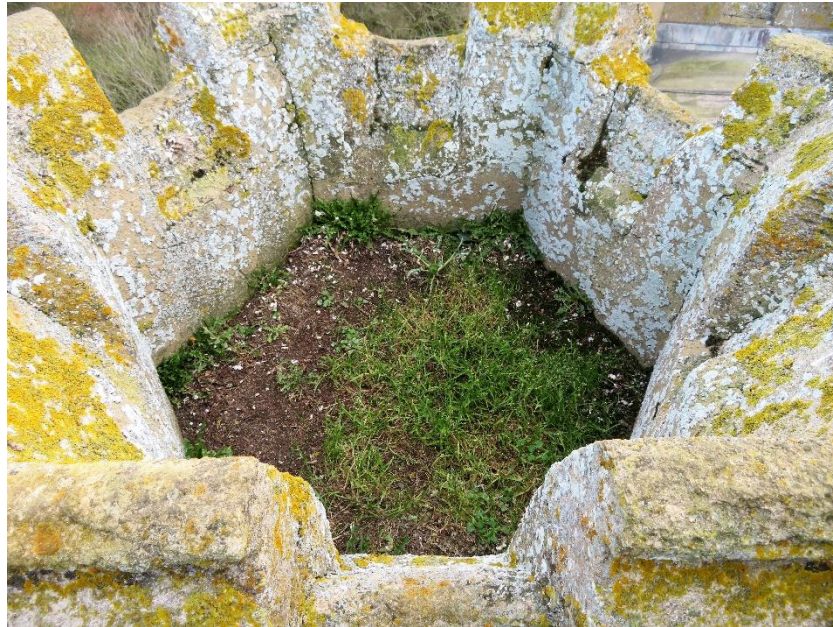
- b) There is a large amount of vegetation and soil on the roof of the northwest turret that needs to be cleared.

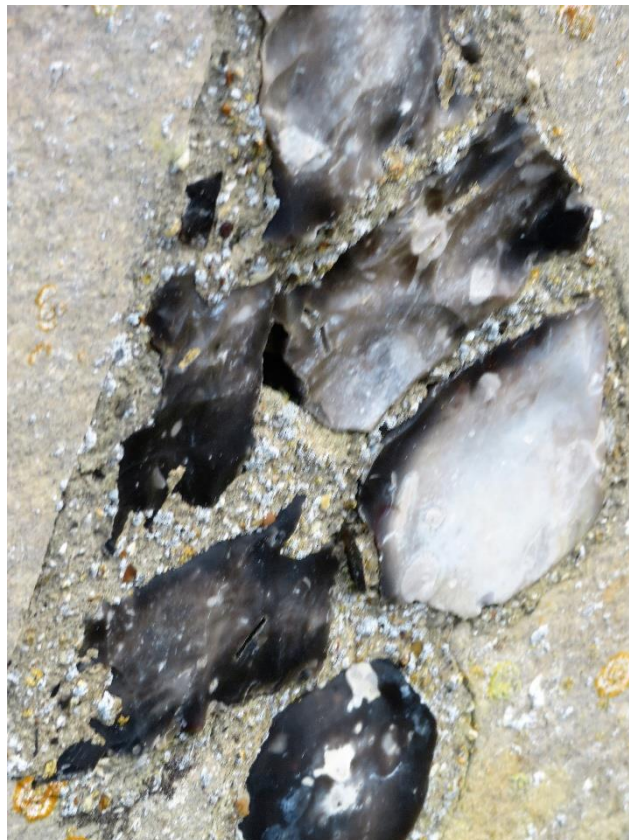
- c) The open joint to the knapped flint panel of the pediment was repointed to prevent water ingress.

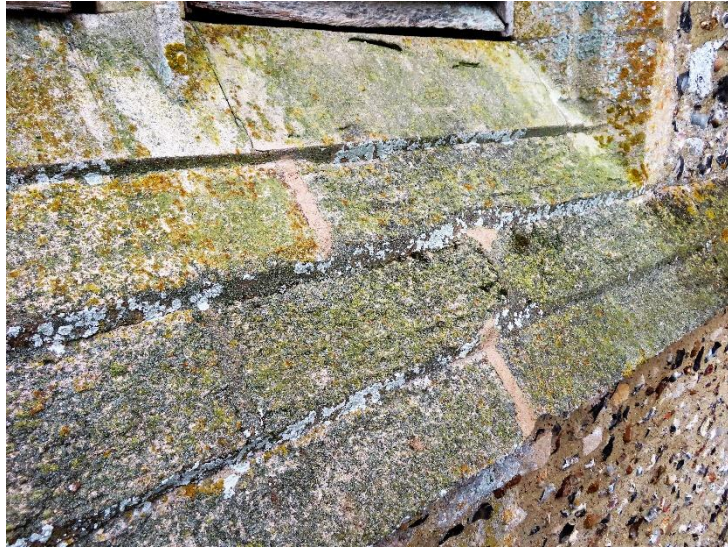
- d) Two dislodged slats to the louvres in the north mainlight of the sound opening were dressed back into position.
- e) Open joints on the cill of the belfry sound opening and to the belfry stringcourse were repointed.

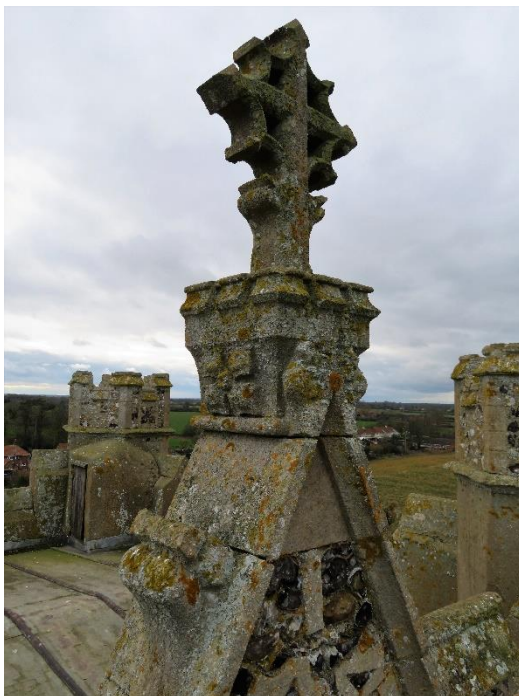
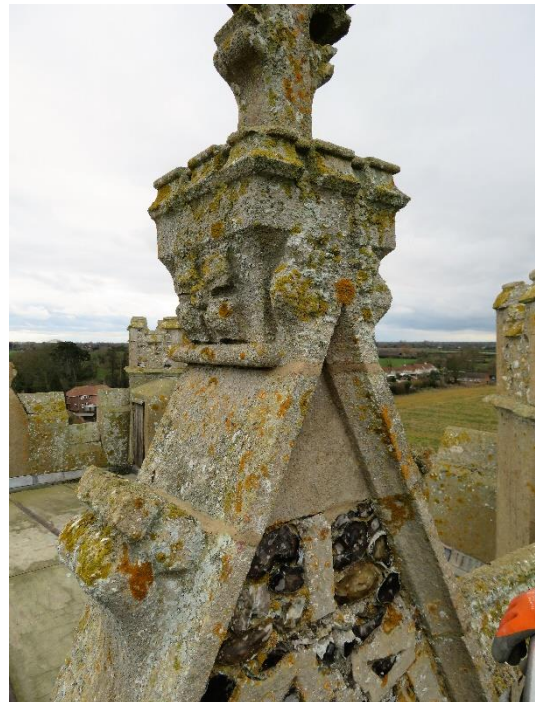
- a) The cross on the parapet pediment is sound but there are open bed joints to the apex stone, to which it is fixed, and open joints to the east coping that have been repointed.

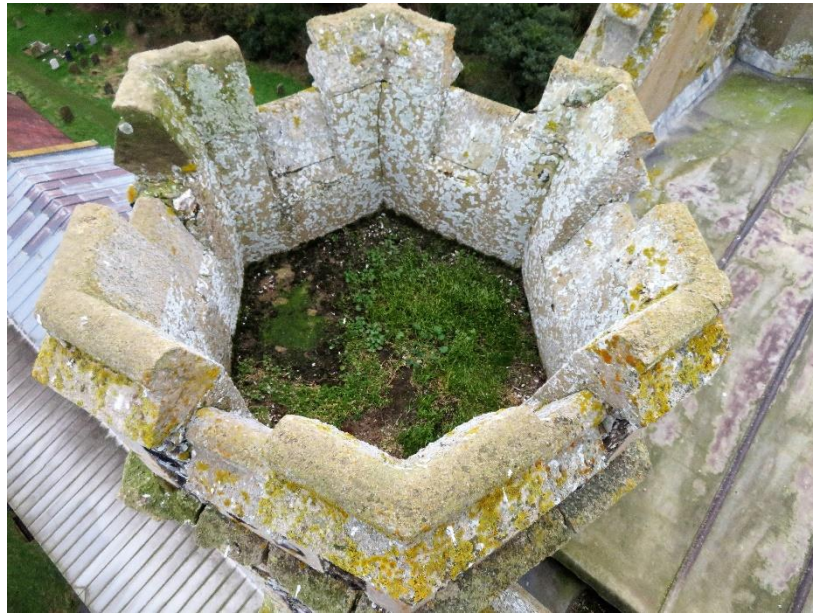
- b) There is debris and vegetation on the roof of the northeast turret that needs to be cleared and the overflow to the northeast rodded.

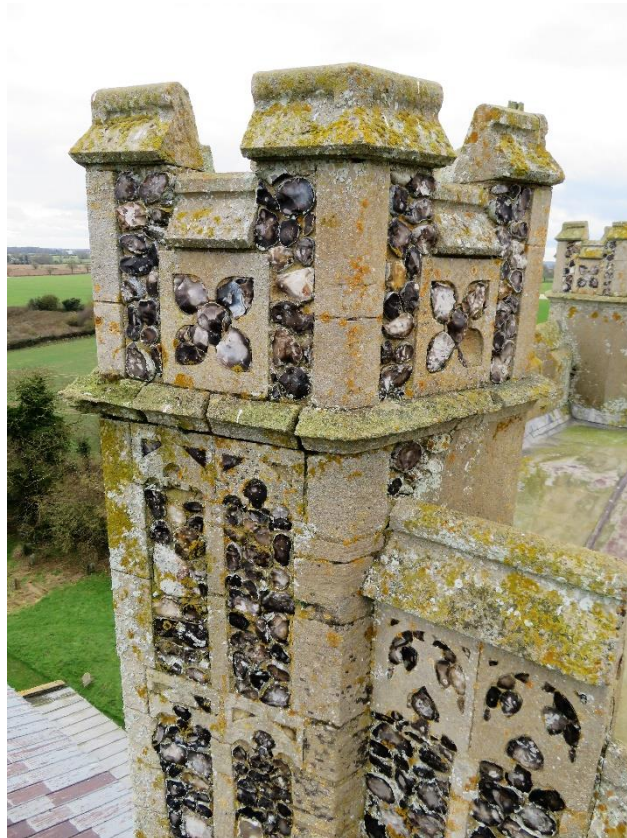
- c) There are areas of recessed pointing to the north facets of the northeast turret and to the stringcourse that need to be repointed.

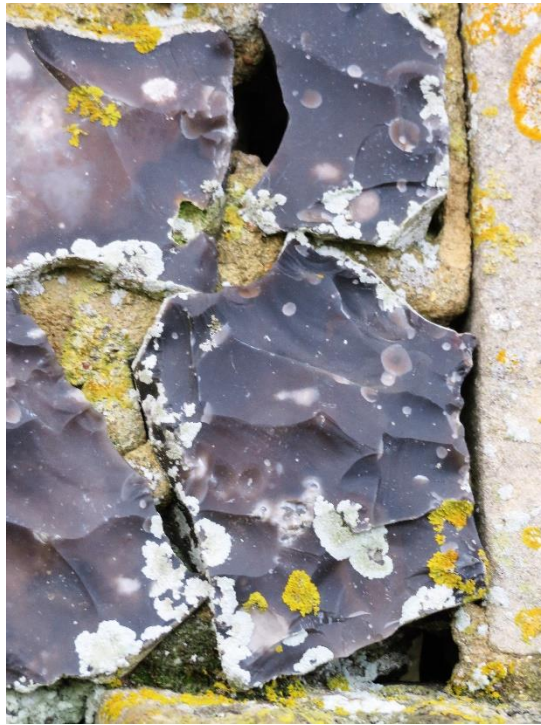
- d) There are recessed joints to the decorative flush flintwork of the north parapet that need to be repointed.

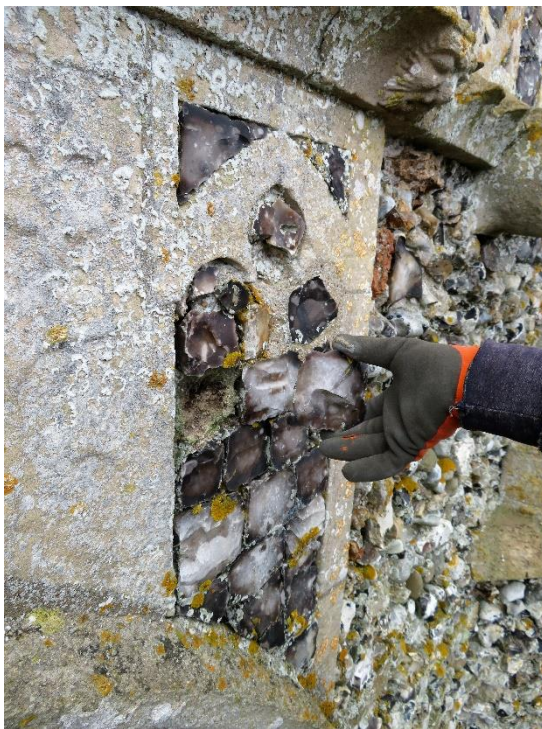
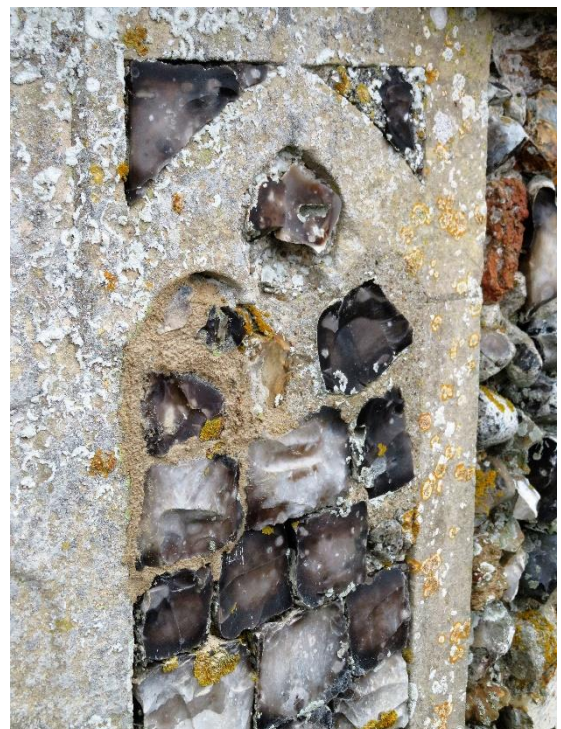
- e) A loose flint to the knapped flint panel to the west of the head of the sound opening was rebedded.

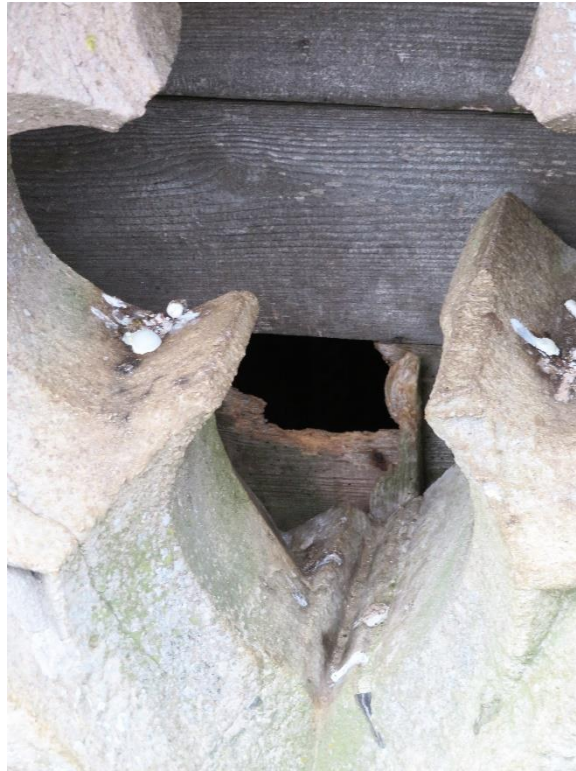
- f) A small hole in the horizontal boarding to the tracery lights of the north sound opening has been closed with stainless steel netting.

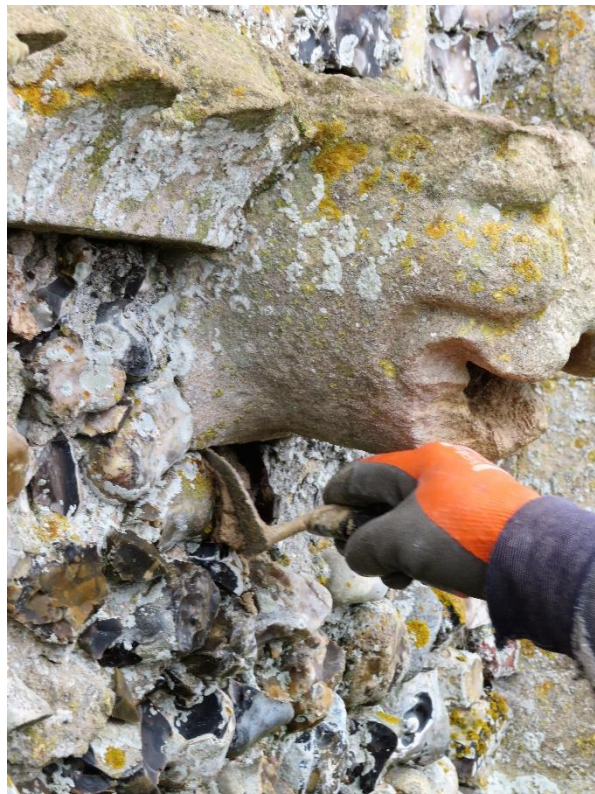
- g) A loose flint was rebbed under the gargoyle.

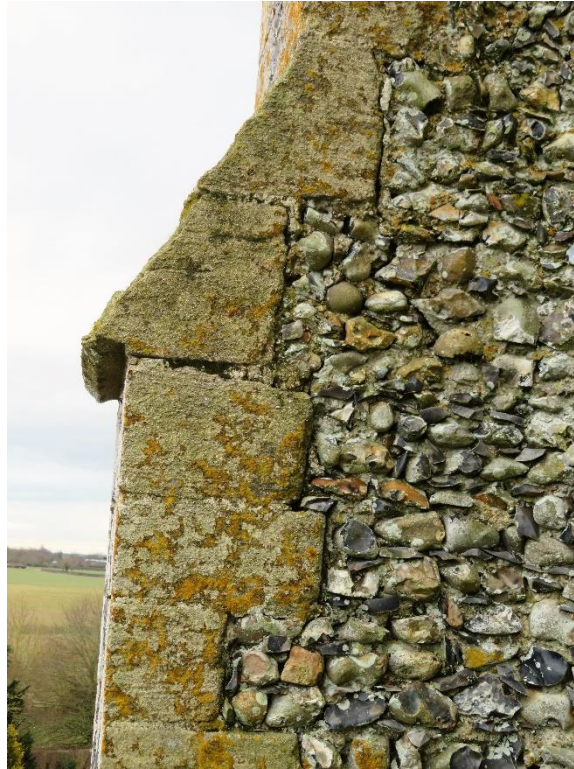
- h) The pointing to the north elevation is generally recessed throughout, but the flints remain sound. There are however margins of deeply eroded pointing behind the quoins to the buttresses that ought to be repointed.

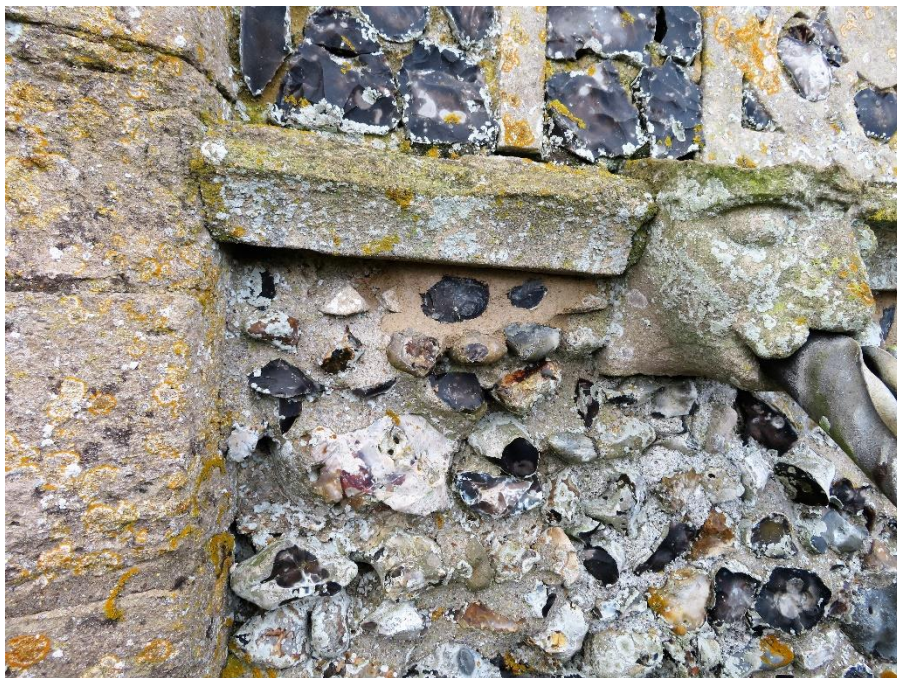
- i) Voids in the flintwork under the east end of the parapet stringcourse were repointed.

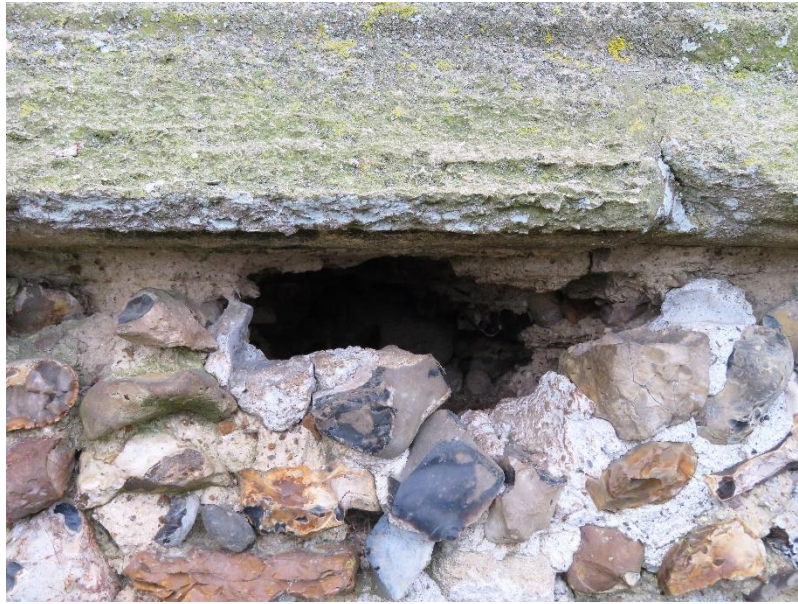
- j) Four dislodged slats to the louvres in the north belfry sound opening were redressed back into position.
- k) The face flintwork to the hole below the belfry sound opening was rebuilt leaving a small gap for bats and birds.

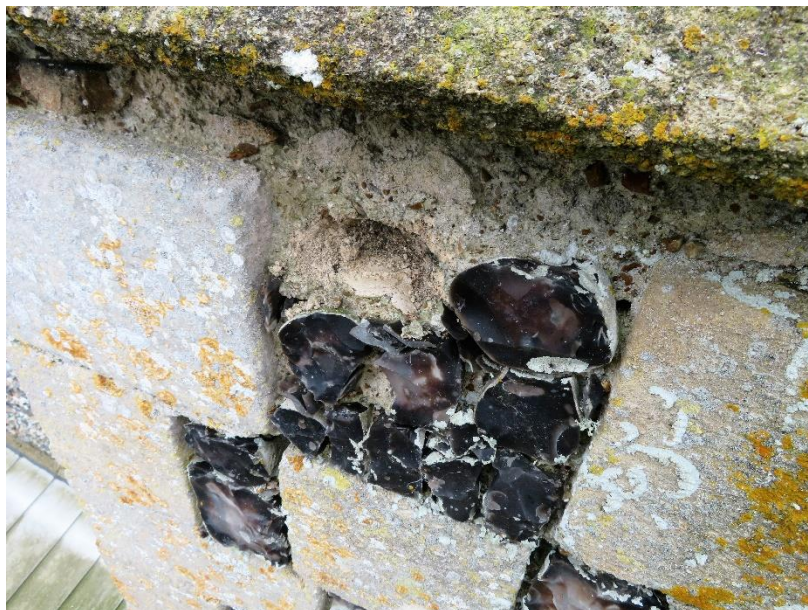
- l) A loose flint was rebedded to the north elevation of the northeast tower buttress, immediately under the stringcourse.

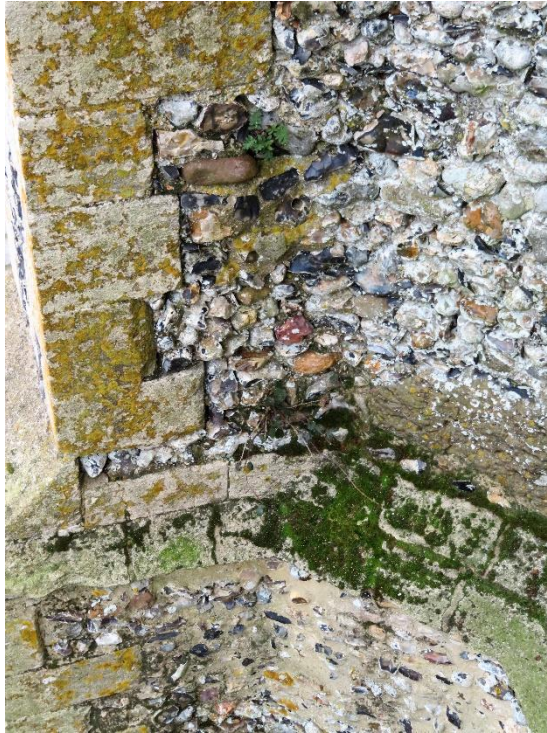
- m) Vegetation was removed from the west elevation of the northeast tower buttress, just above the silence chamber stringcourse.

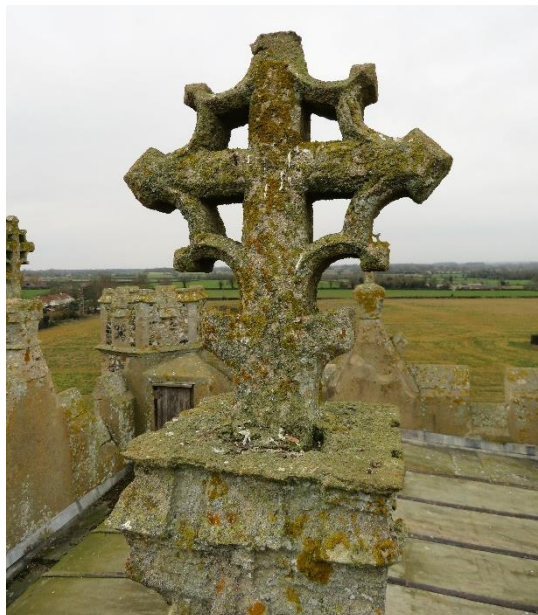
- a) The cross is secure but the open joints to the base was pointed and flaunched to shed water.

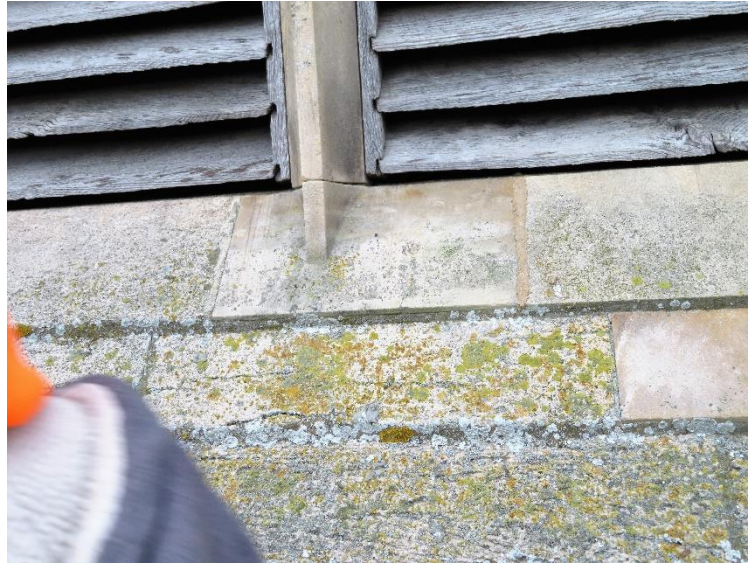
- b) There are localised areas of recessed pointing to the northernmost panel of the east parapet flushwork.
- c) An open joint was pointed on the cill of the sound opening.

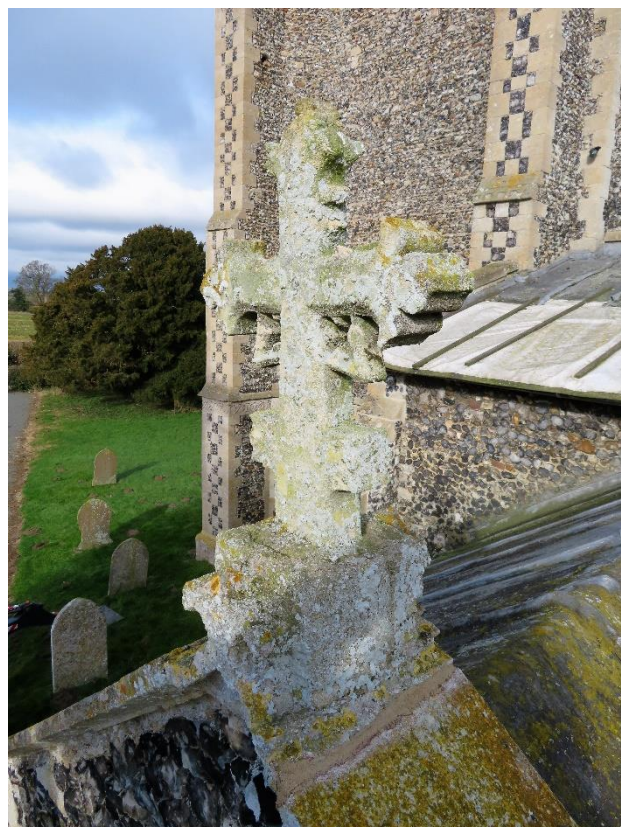
- a) The apex stone, supporting the cross is loose and has been slate wedged and pointed but in the longer term ought to be rebbed.

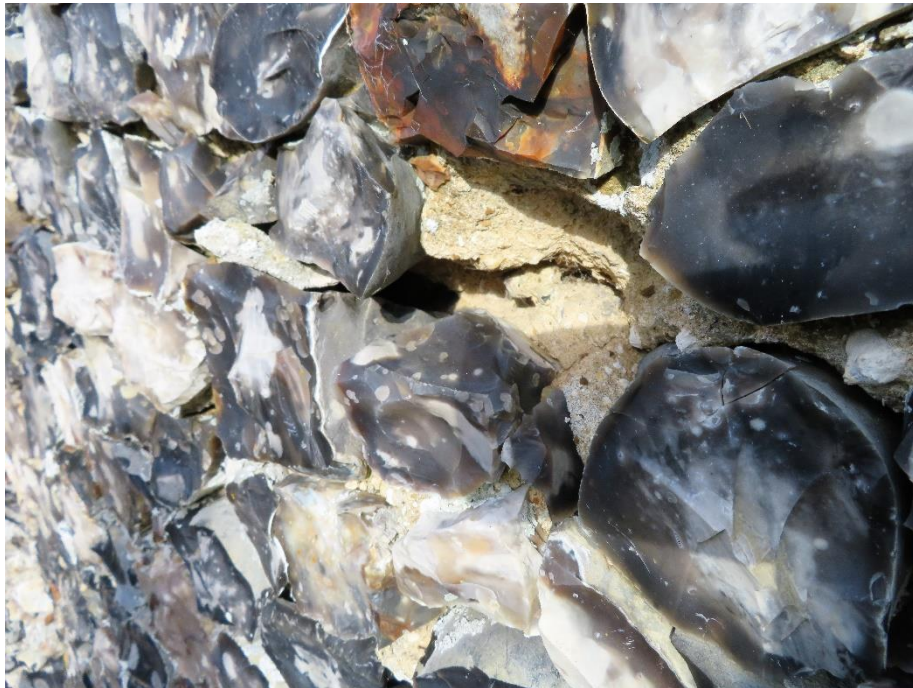
- b) There are deeply eroded joints to the gable flintwork and one loose flint that was identified has been rebedded leaving a void behind for bats.

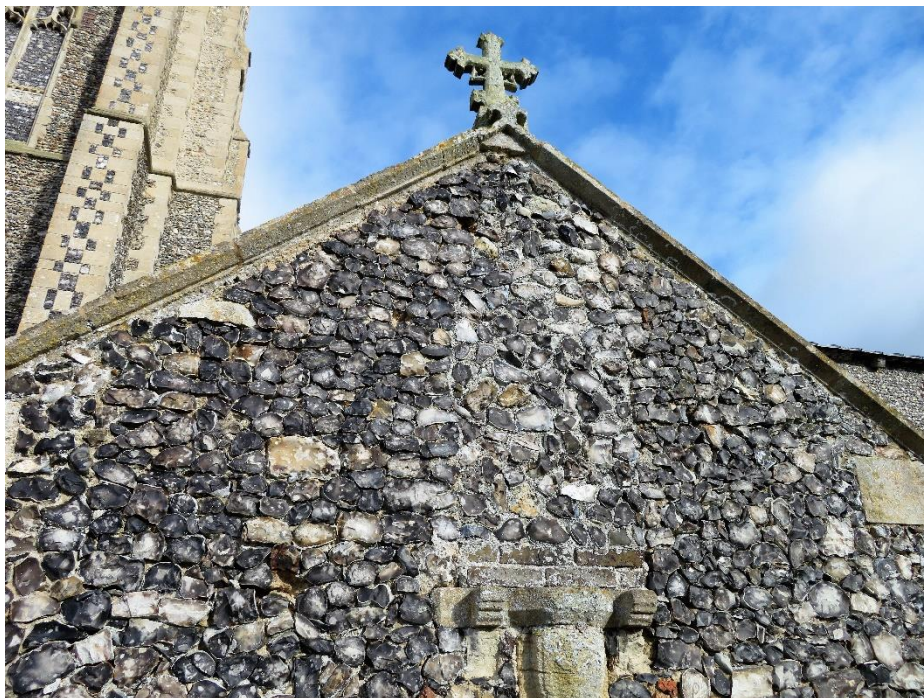
- c) There is deeply eroded pointing throughout the south elevation to the porch that needs to be repointed.

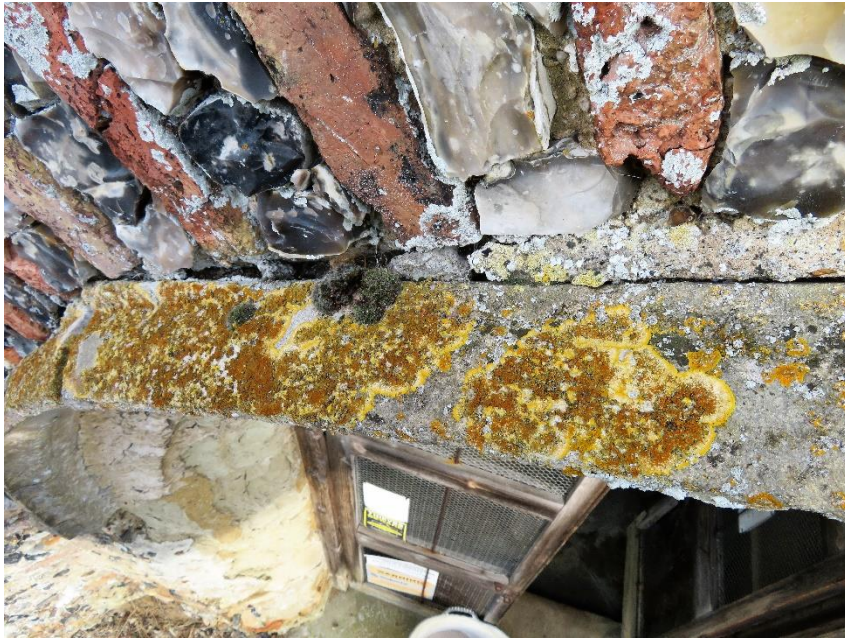
- d) There are deep open joints behind the hoodmould stones that need to be repointed to prevent water ingress to the wall and to secure the hoodmould stones.
