The Parish Church of St. Andrew
at

DEOPHAM : NORFOLK

THE NINTH QUINQUENNIAL INSPECTION REPORT

Date of Inspections : Wednesday 26th January, Friday 4th and
Wednesday 9th February 2022
RAB:LEB

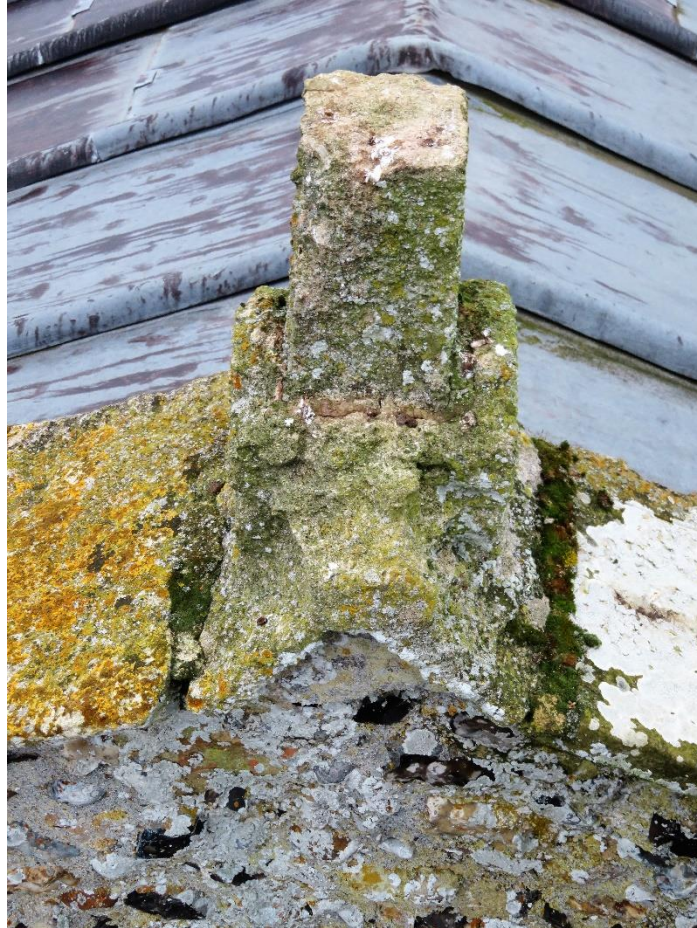
- a) The cross is loose and repointed in-situ although it ought to be rebedded.
